BY HOGAN LTD

2.0 SUMMARY

Further to instruction on (date) Hogan Associates attended the above property on the afternoon of (date) to carry out a building survey.

This substantial, freshly modernised, end of terraced property faces in an easterly direction and provides accommodation by way of five bedrooms, over five floors, from basement¹ through to third floor complemented by a roof terrace and access to communal gardens to the rear of the property.

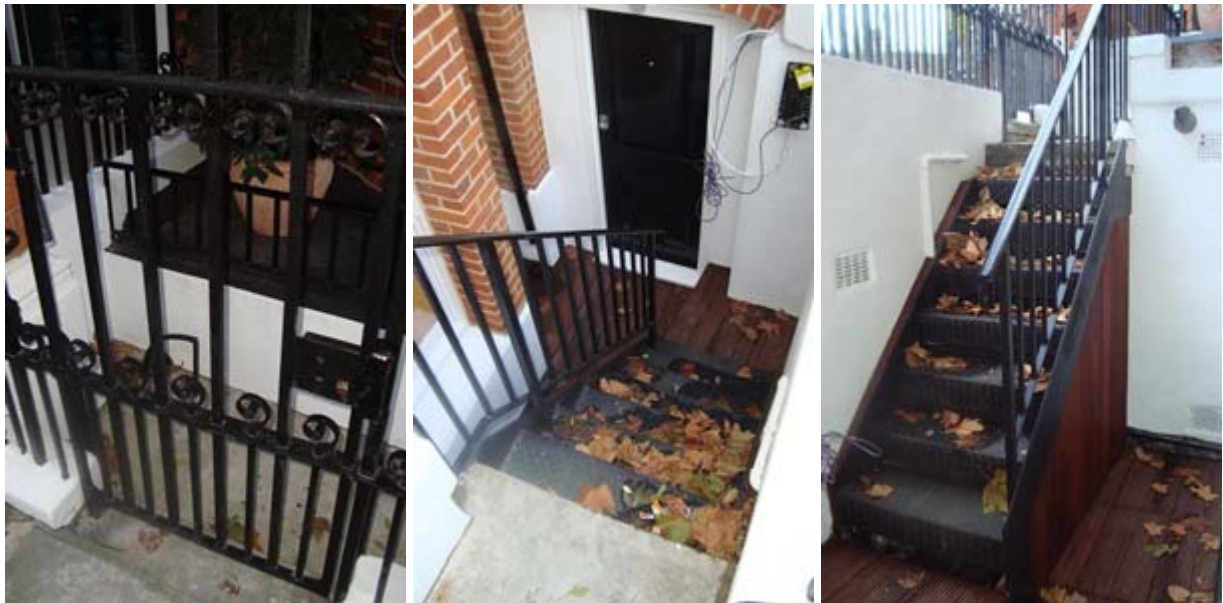
Within the light well area there is access to the incoming electrical mains panel via a locked cupboard beneath the pavement and there is also to the left the housing containing the boiler which is accessed via the basement bedroom.²

BT wiring needs to be tidied and the rainwater pipe needs extending into the gulley.

The area is a trap for leaves.

² A carbon monoxide monitor is recommended

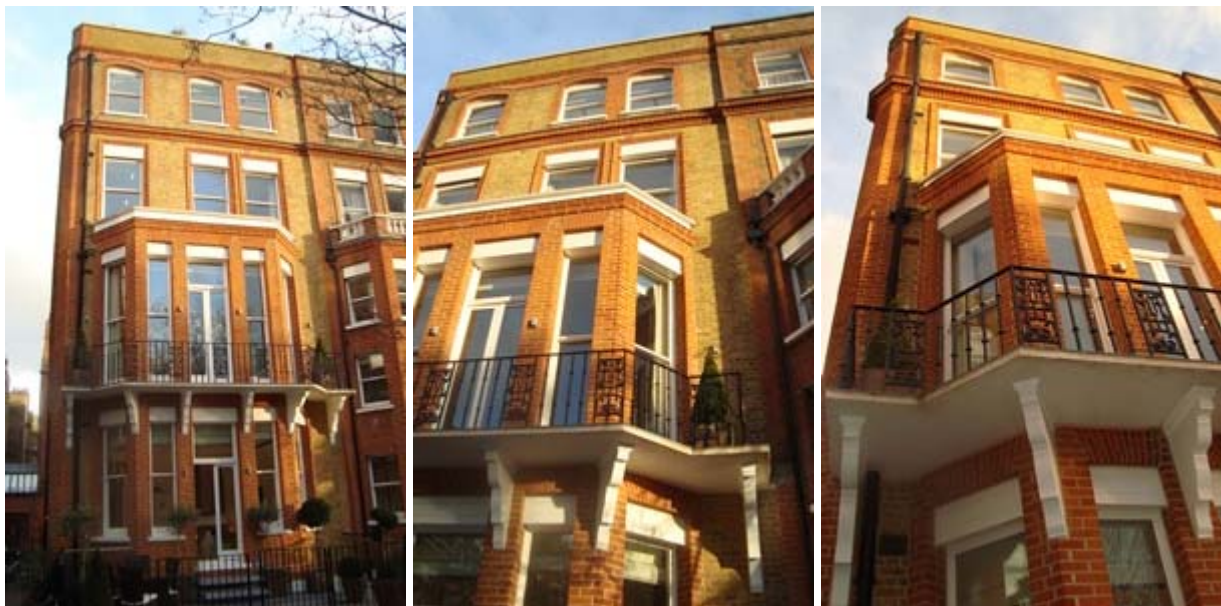
With regard to the stone balcony to the rear (at first floor level) this appears structurally sound – there are no indications of any distress and it is supported by 6 buttresses.

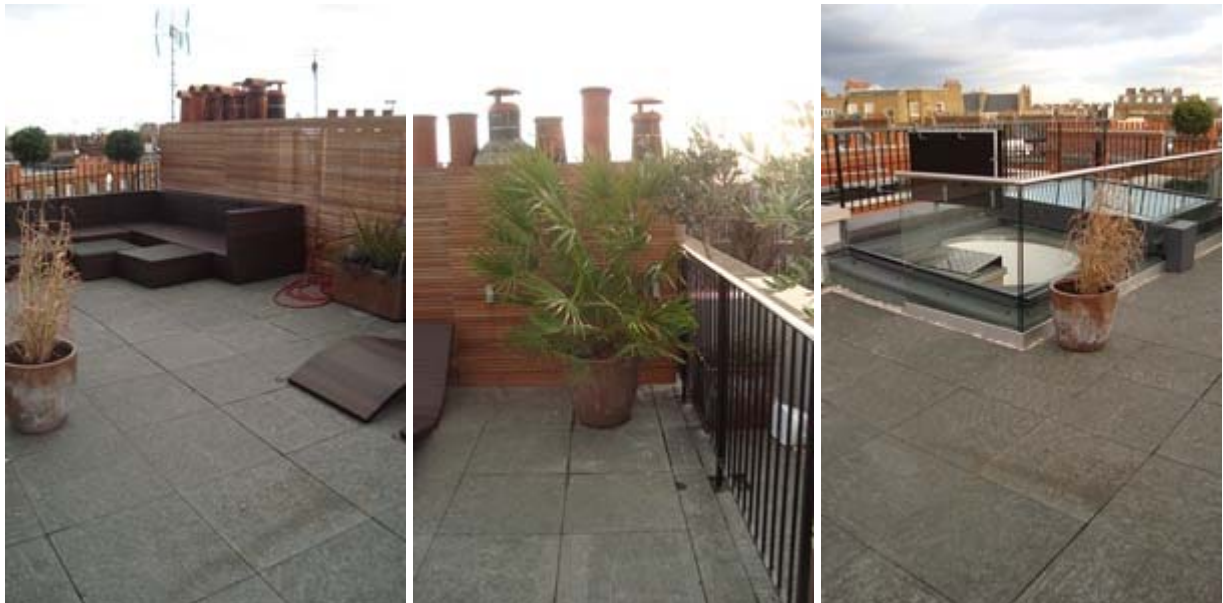
The roof terrace has taken advantage of the greater area of space available but there are safety rails set back from the east and west elevations with a third rail on the parapet wall forming top of the side elevation.

There is a timber slatted fence mounted against the party wall (which has feature lighting to the right) – it also has a power socket and water supply. Some minor “making good” to the lead work is required:

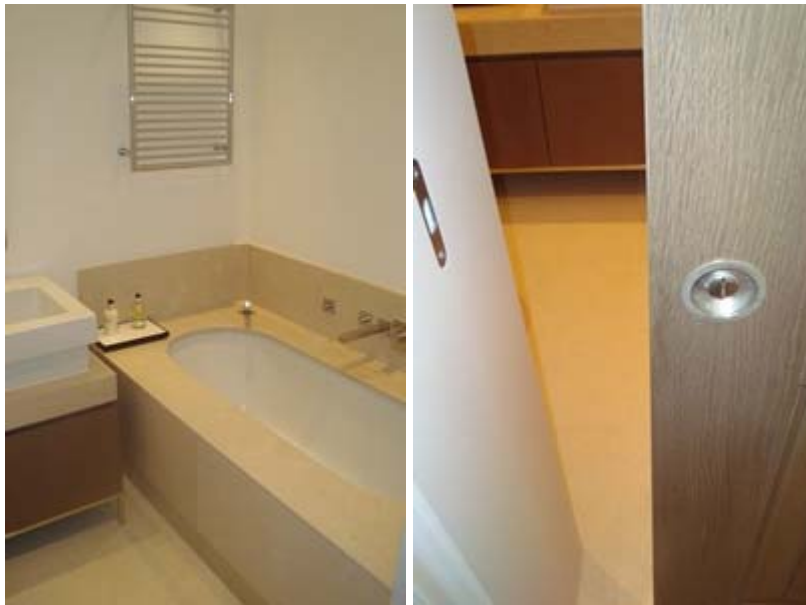
The sliding door to the bathroom requires easing and is very heavy. It is also difficult to open given the recessed type of ironmongery.

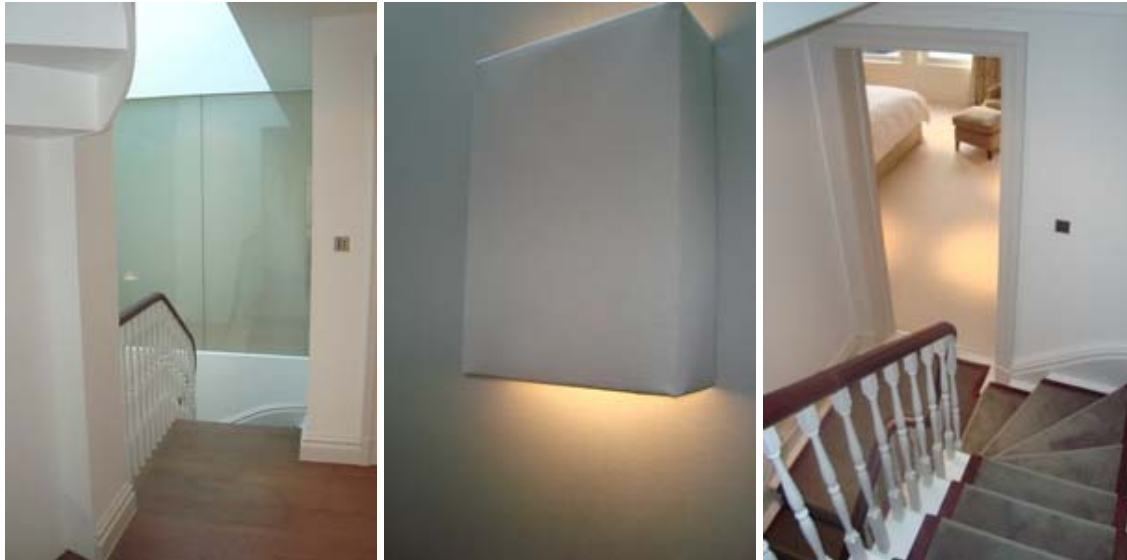
The wall light shades are loose and not durable.

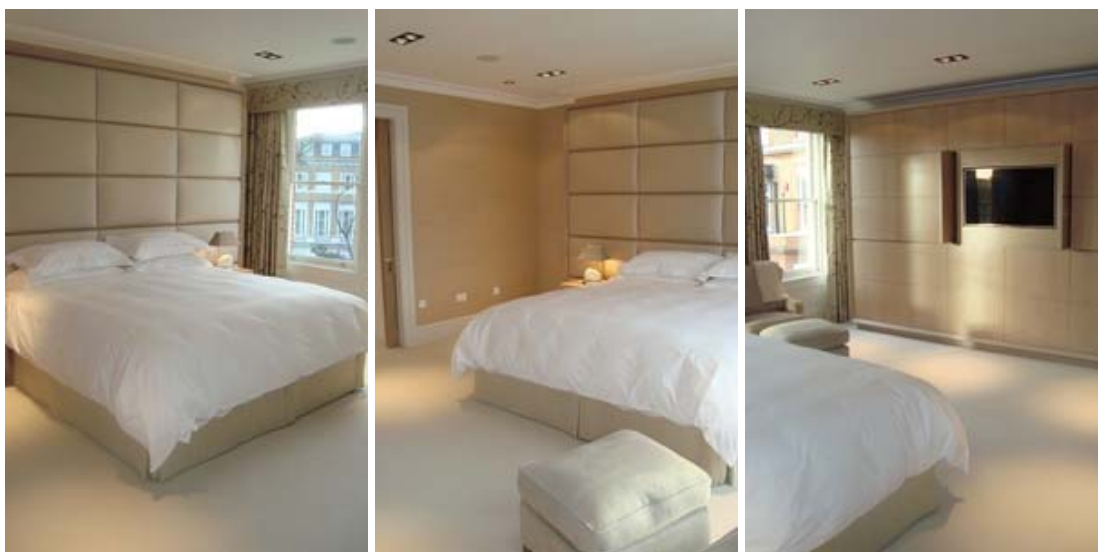
The master bedroom is provided with three sash windows which overlook the main gardens (and bay structure to the first floor and kitchen, below). There is some minor making good required to the felt above the lead work.

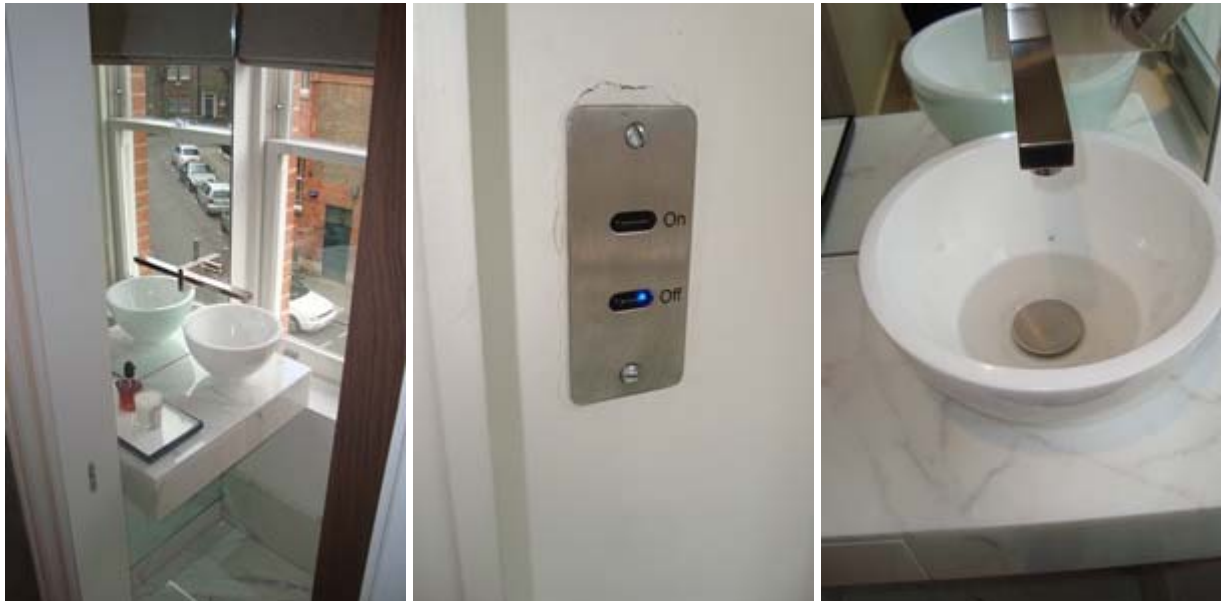
This is provided with two sash windows together with a W.C. and wash hand basin and both sanitary items function correctly, although water tends to drain away slowly from the wash hand basin.

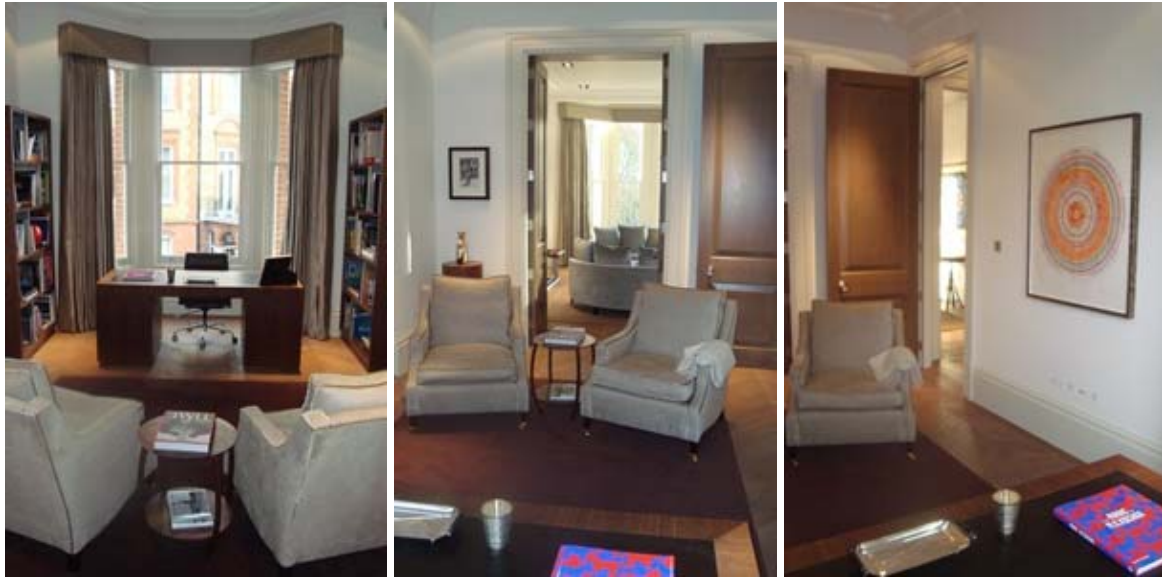
Again this is provided with a coal effect gas fire. There is a slight opening to the parquet flooring (which is predominantly covered by rugs) e.g. to the left of the main desk when viewed from within the room.

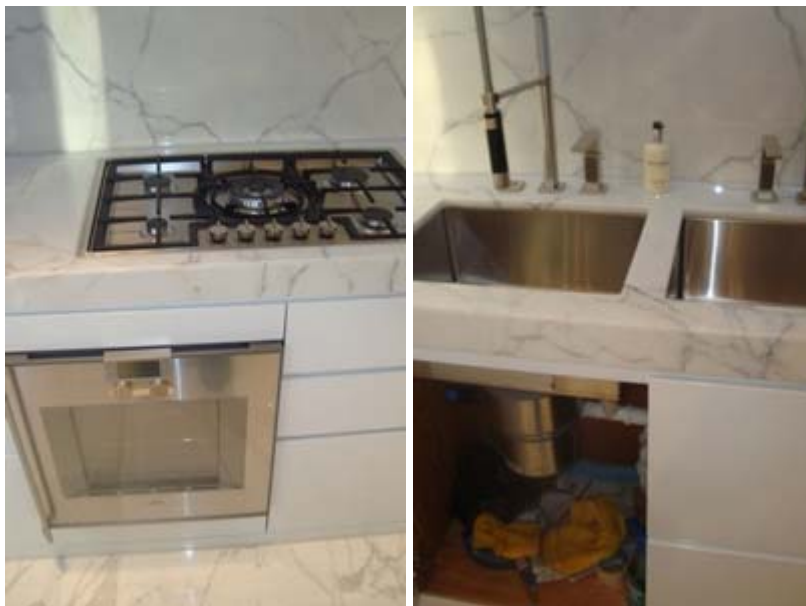
Again there is cupboard space below which is illuminated either side of the Miele extractor system which in operation is extremely noisy and not very effective.

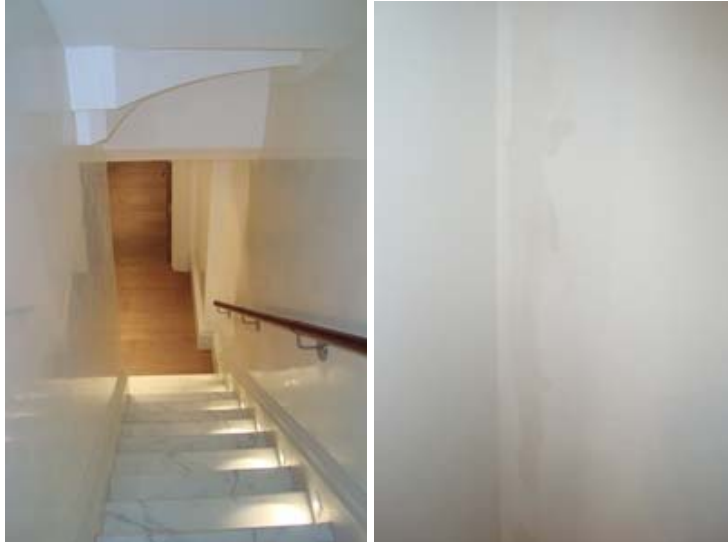
The substantial front door is provided with a Banham mortice lock, just above eye level, and a latch lock at approximately 1.5 metres. There is also a viewing hole within the centre of the door to the left of which there is a Lion security control system panel. There is a small sash window to the left again when viewed from within the hallway. There is minor cracking to decoration to the side of the staircase.

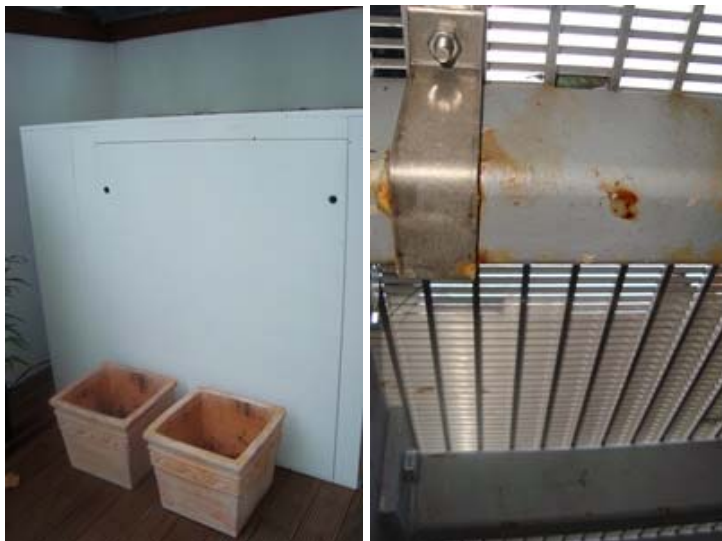
Photograph of stairs down to basement noting that there is some water ingress to the polished plaster and it is believed that this is to be replaced along this wall.

Air conditioning equipment beneath patio. Rusting to underside of patio:

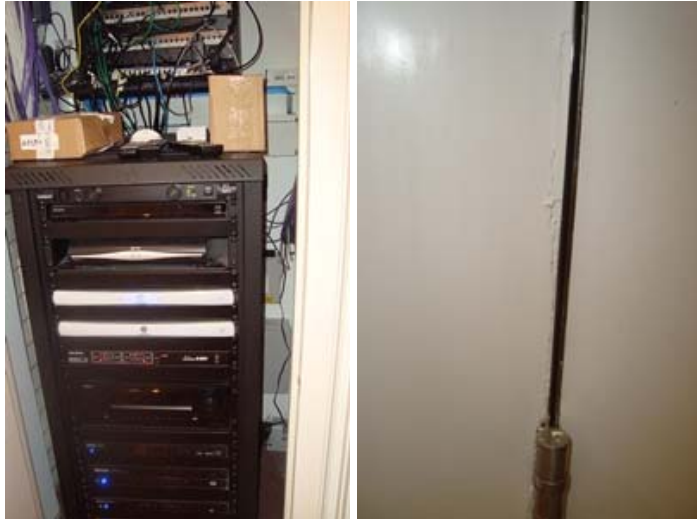
As photograph below and note minor redecoration required close to the hinges particularly at the bottom.

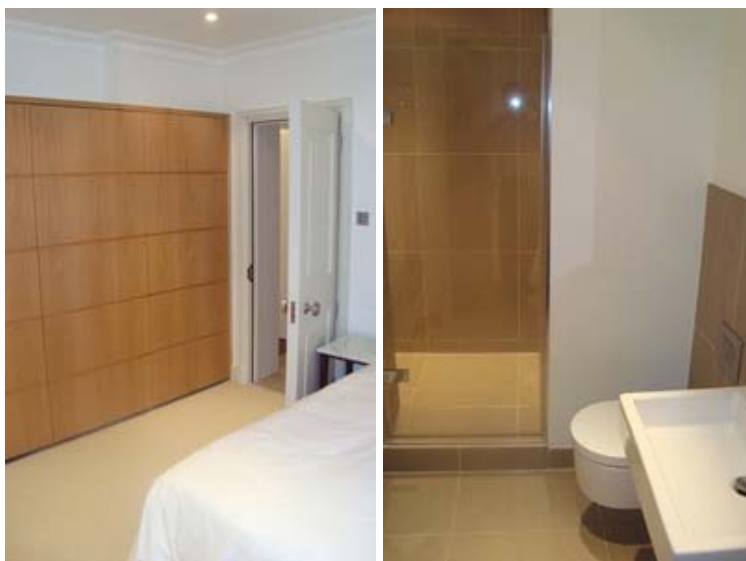
This room is provided with one inset double wardrobe (with automatic lighting) and to the right upon entering there is a mock wardrobe system (note dust trap above).

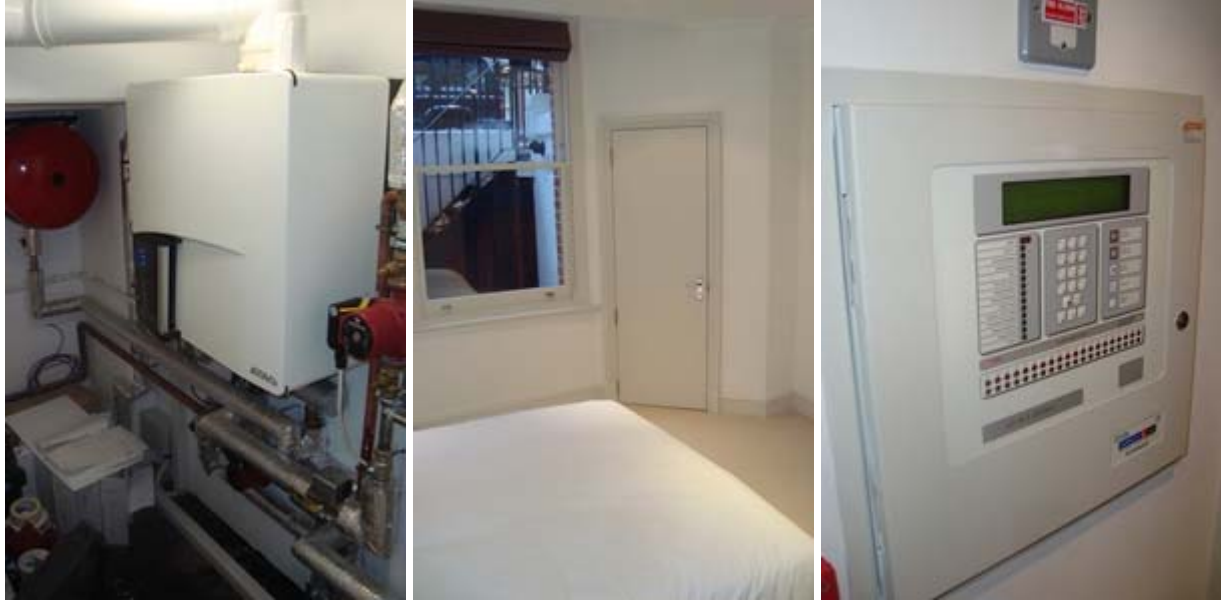
To the right of the two sash windows there is the access to the Atag boiler system and pumps and within this room there are operation and maintenance manuals.⁵

⁵ Some damp ingress is to be attended to.

It would be sensible to have a carbon monoxide monitor within the bedroom.
