HOGAN LIMITED

1.0 SUMMARY

Further to instruction on 10th September 2020 Peter Hogan FRICS of Hogan Ltd attended the above property on the afternoon of Monday, 14th September 2020 to carry out a building survey.

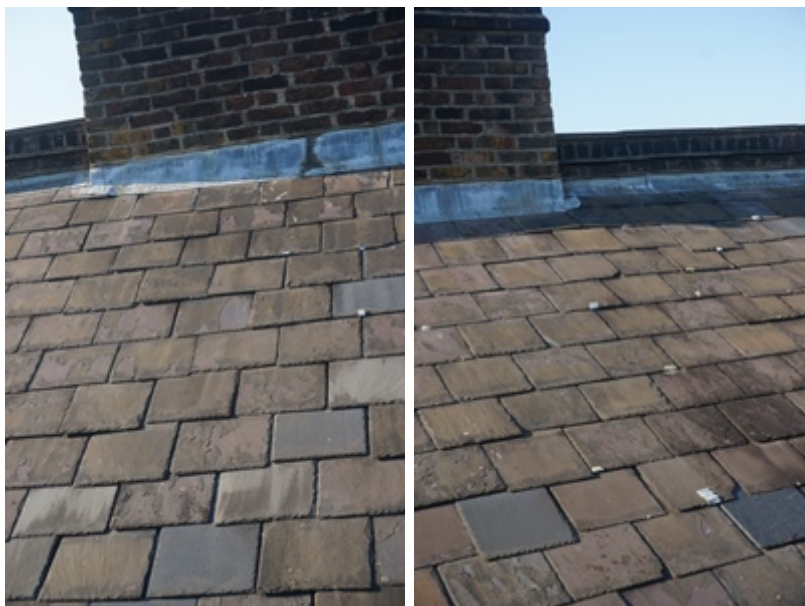
However, the roof slates are clearly suffering from systemic nail fatigue, i.e. with the nails assumed to be ferrous and there are a great number of slates which have been re-fixed using 'lead tabs'.

These will continue to slip and require replacement though the roof can be maintained for many years to come, but clearly a decision was made to do this given the relatively new refurbishment to other areas, and the rear roof has been covered with a synthetic tile noting the breather vents set up towards the ridge line which has on the top of it a metal capping with lead detailing beneath dressing onto the synthetic slates; this structure being the gable wall.

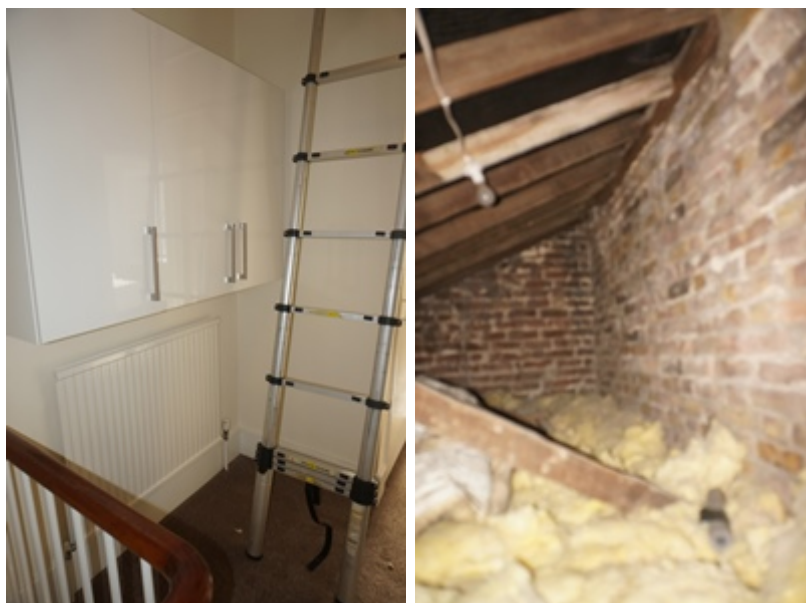
It was noted that, as is traditional, the top of the roof is held up by a timber wall plate which sits on corbelled brickwork which would not comply with Building Regulations but is thought to be quite adequate and there is at the centre height a purlin which also has intermediate supports.

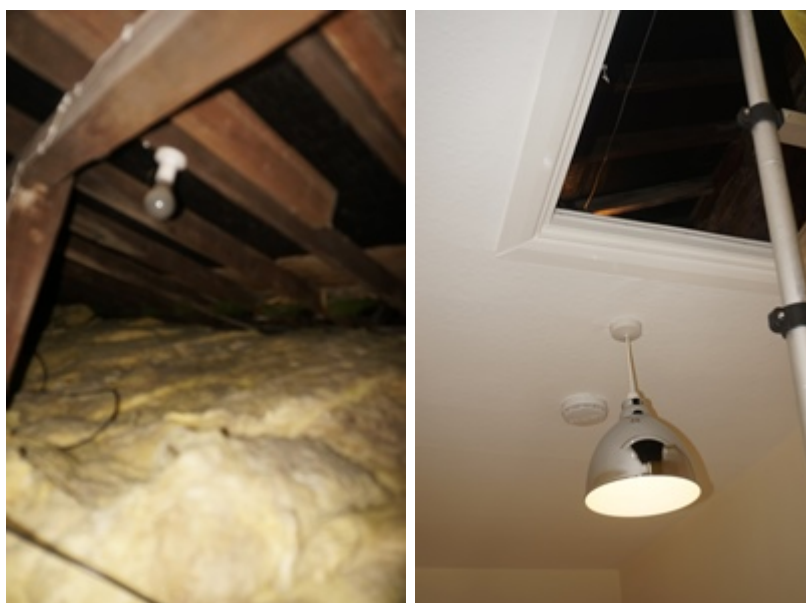
There is a large water tank and it is assumed that this is suitably structurally supported though this certainly could not be determined and its presence is questionable given the modern equipment beneath.

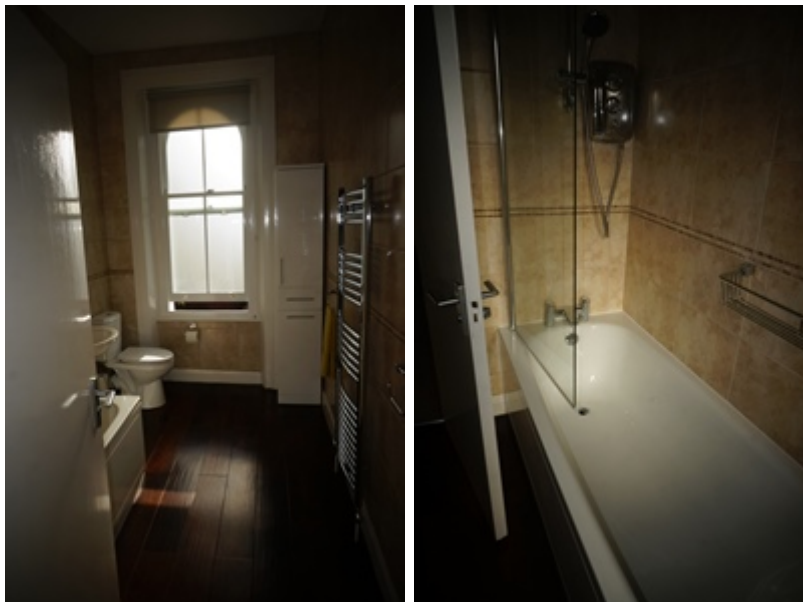
There is a bath to the left with shower screen and shower equipment, noting that the hot water is supplied by an independent unit and note the coarse external surface wiring to the extractor fan above this area.

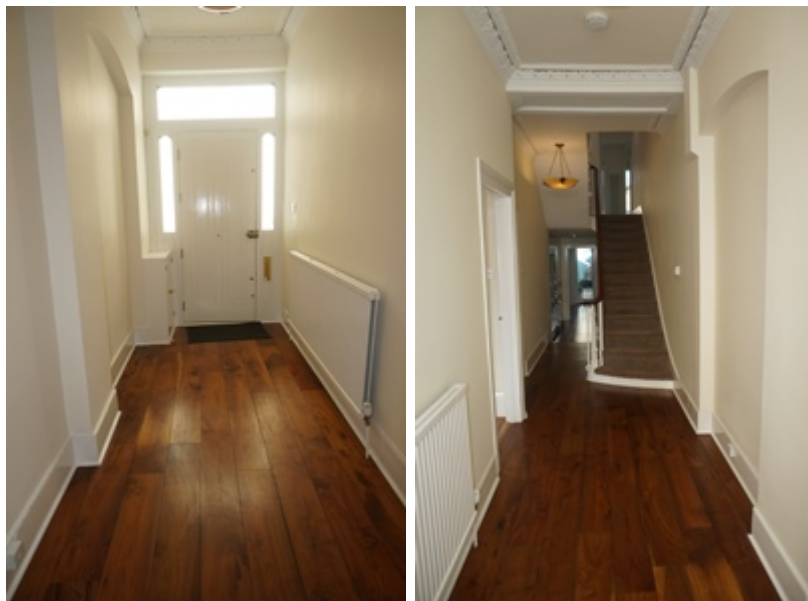
There is a fairly robust front door with a latch lock, 5-lever mortice lock and dead bolts top and bottom. The dead bolts and 5-lever mortice lock should be changed for a “thumb-turn” so that a key is not required to escape in the event of fire.

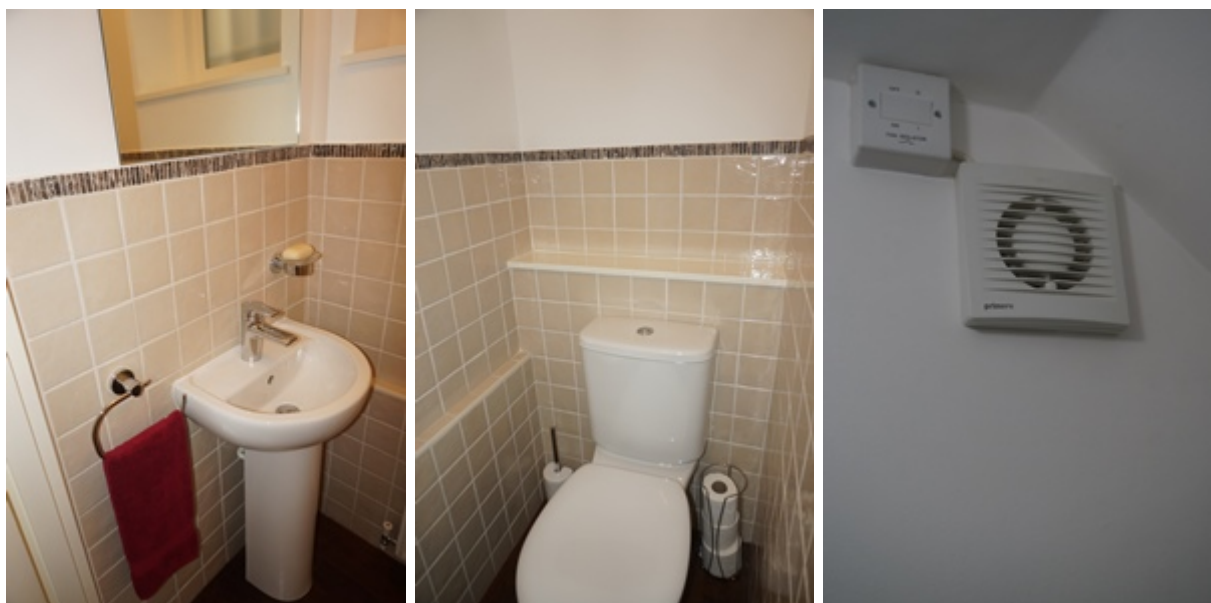
This is to the right towards the far end of the hallway down two steps and to the left inside there is a pedestal wash hand basin with mixer tap, the obscure fixed window (without vent) and close coupled floor mounted WC and to the right there is a Primero extractor fan above and to the right of the window which operates via **the light switch which should be outside of the room as this is currently not compliant with safety Building Regulations. It was noted that the door opens into the corridor which could be hazardous** and the lock on it can be overridden from outside.

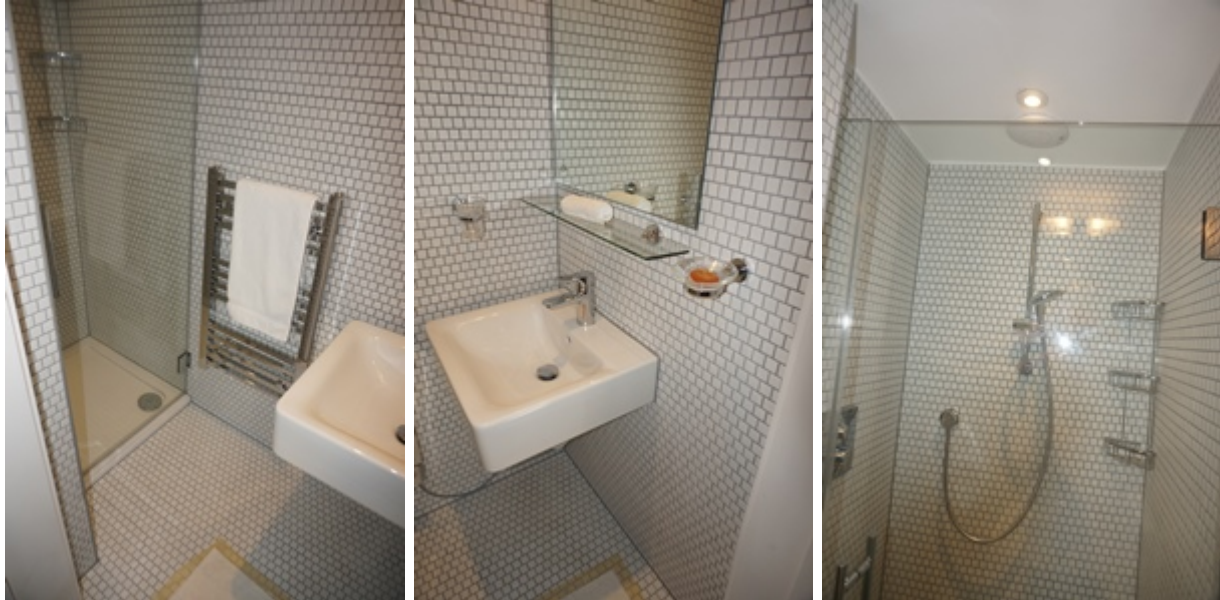
Within the en suite, **which has a sliding door which can be something of a finger trap**, there is a shower unit to the left and an extractor fan above and it is assumed that in all wet rooms the lighting is moisture proof.

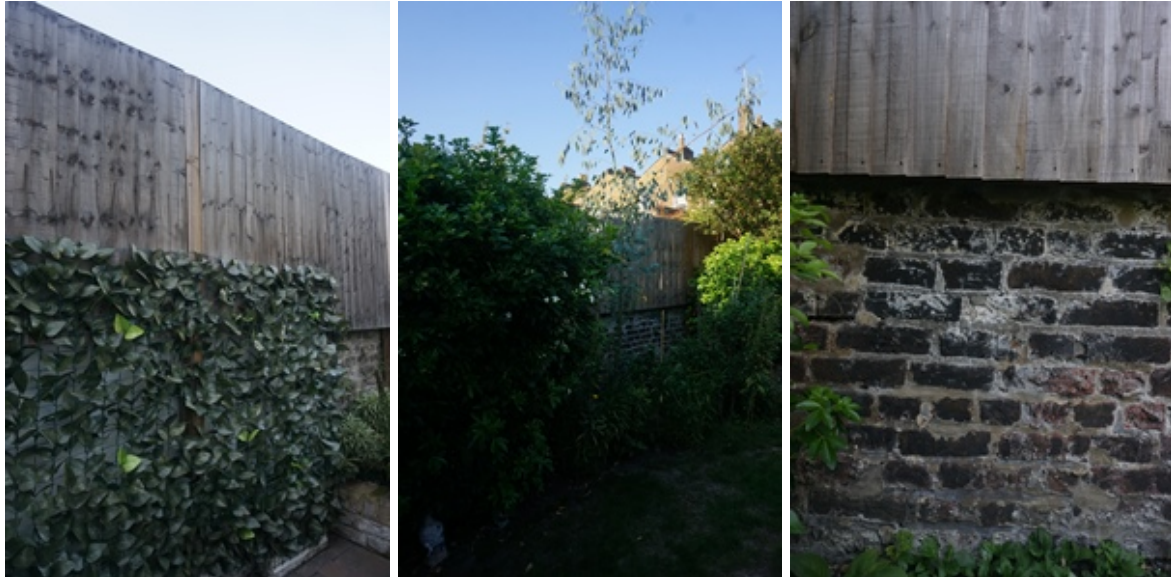
To the left there is a very aged assumed solid 9" wall on top of which there is an elegant timber fence and the fence would benefit from preservative and the wall is generally in reasonable condition though there is some coarse repointing and further repointing would be appropriate and noting some spalling (frost shattering) to the face brickwork, e.g. approximately 5m from the rear wall which is also of solid construction and again has a timber fence on it but in this case on the neighbour's side.

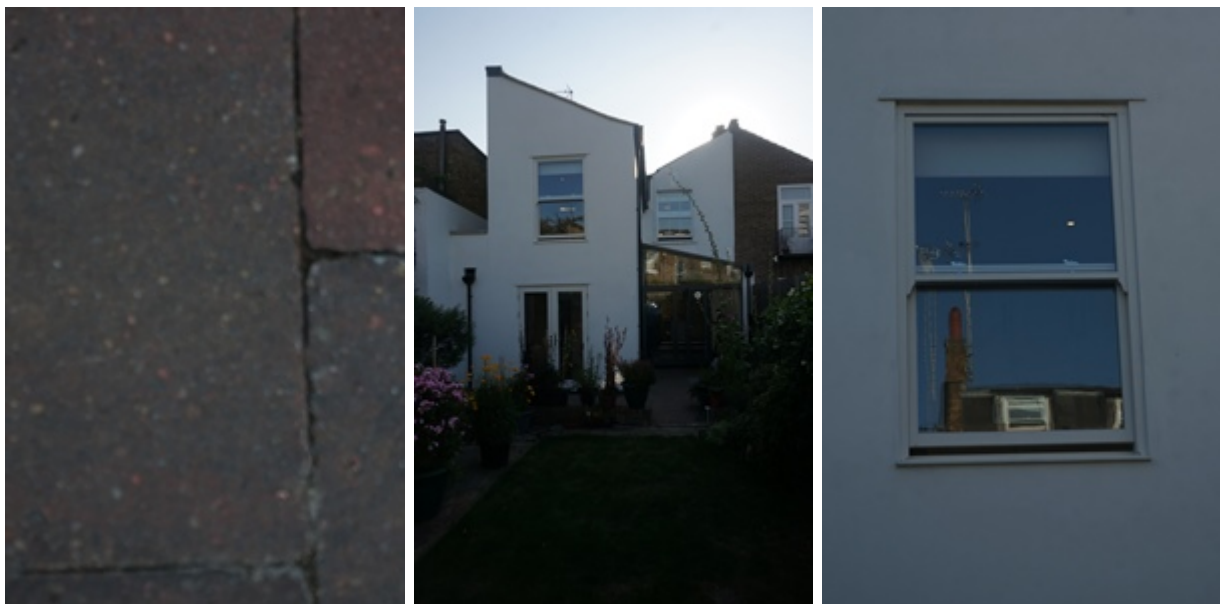
Turning to the main building, all of the external surfaces are rendered which can tend to be a short term solution as inevitably rain after only a couple of years will tend to soil the façade if not allowing water behind which will then freeze and disturb the surface but at the moment it appears to be in good condition although there is some aberration to the paint above the first floor window to bedroom 3.

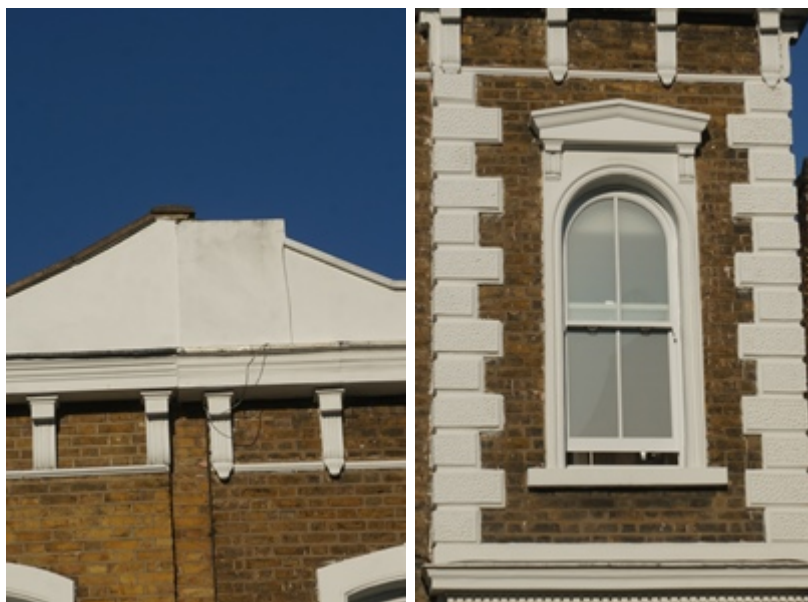
On the far side of the road it is possible to view the chimney pots to the stack. In comparison with the property at number 14, the brickwork is still soiled and noting the recessed section presumably defining the position of the party wall.

With respect again to relatively new decorations, there was no sign of any distress to the quoin stones or stone reveals at heads and sills to the first floor and ground floor windows and for example to the upper pediment detail, i.e. above the first floor window but some of the decoration is failing and there is water staining coming off the assumed lead parapet capping.

Also the bricks just below this level are beginning to spall and require attention and better preparation before decoration is necessary particularly to the attractive stone elements to the upper ground floor window and indeed either side of the main entrance.

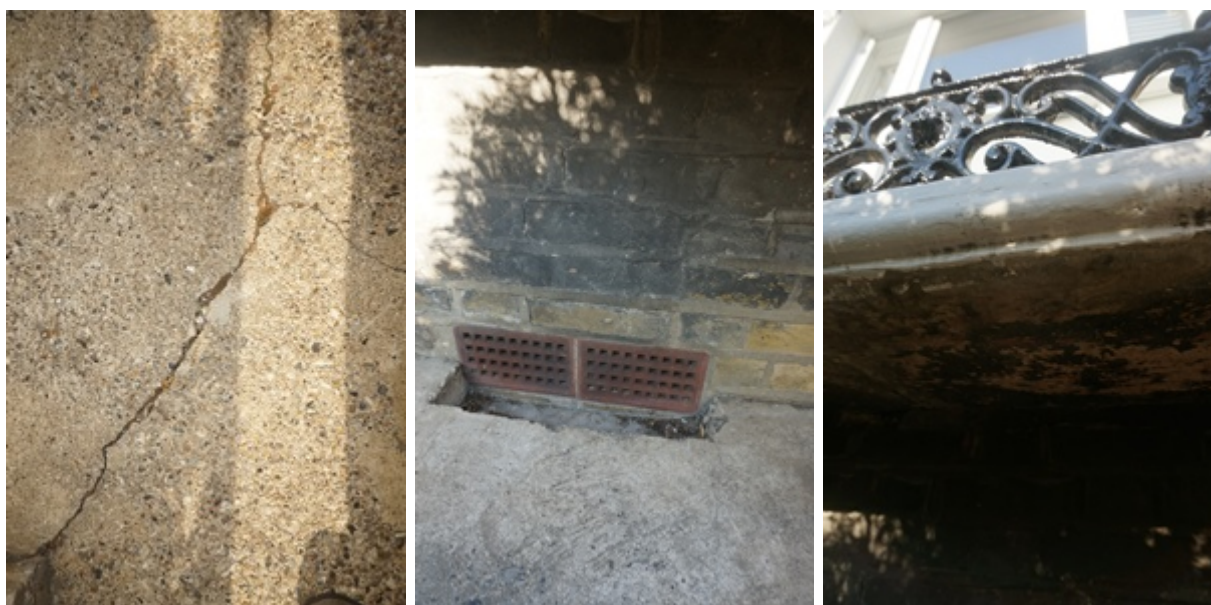
At the base of the left hand façade there is a wide window sill which has a crack in its centre which has been repaired many times, as have the railings, and beneath this there is a twin breather vent noting this is recessed suggesting that the concrete to the greater part of the front garden is raised beyond an original level possibly to allow a greater (draining) slope out onto the pavement and generally while this concrete is cracked, particularly in front of the entrance doorway, some of it has been cut away and re-laid (but not clear why this has happened) and the aggregate is 'grinning through' which means the areas is quite slippery when wet or frozen and note the concrete does not extend behind the bin store.

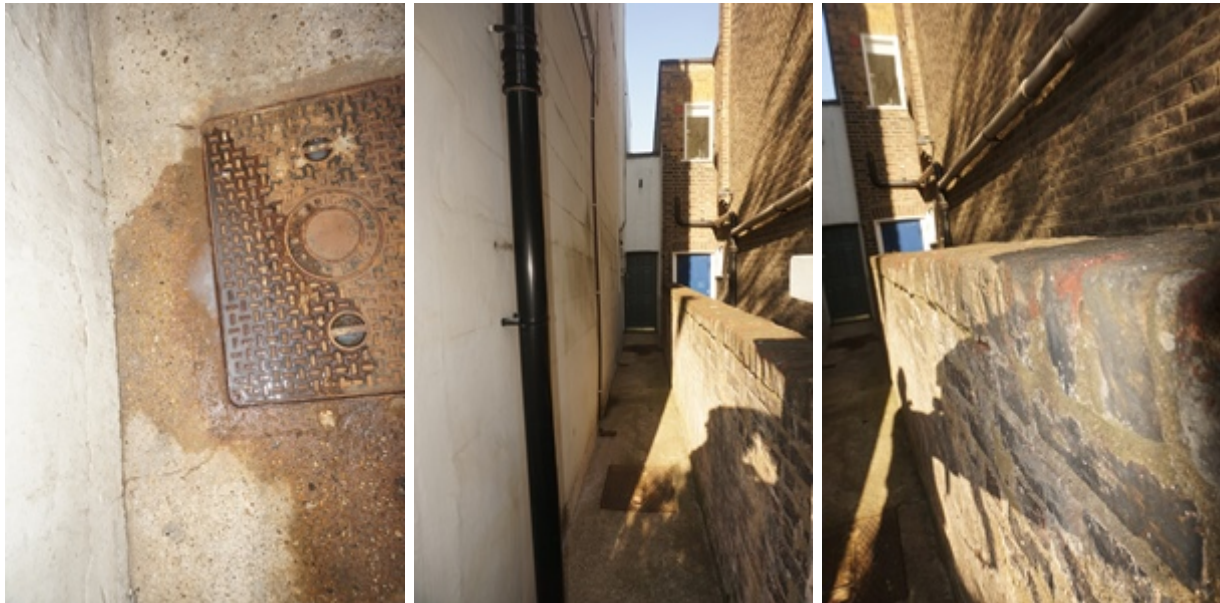
There is an awkward step down to the side alleyway which has a similar concrete ground specification and noting that there is effluent leaking from the far manhole with a pungent smell and obviously this should be investigated.

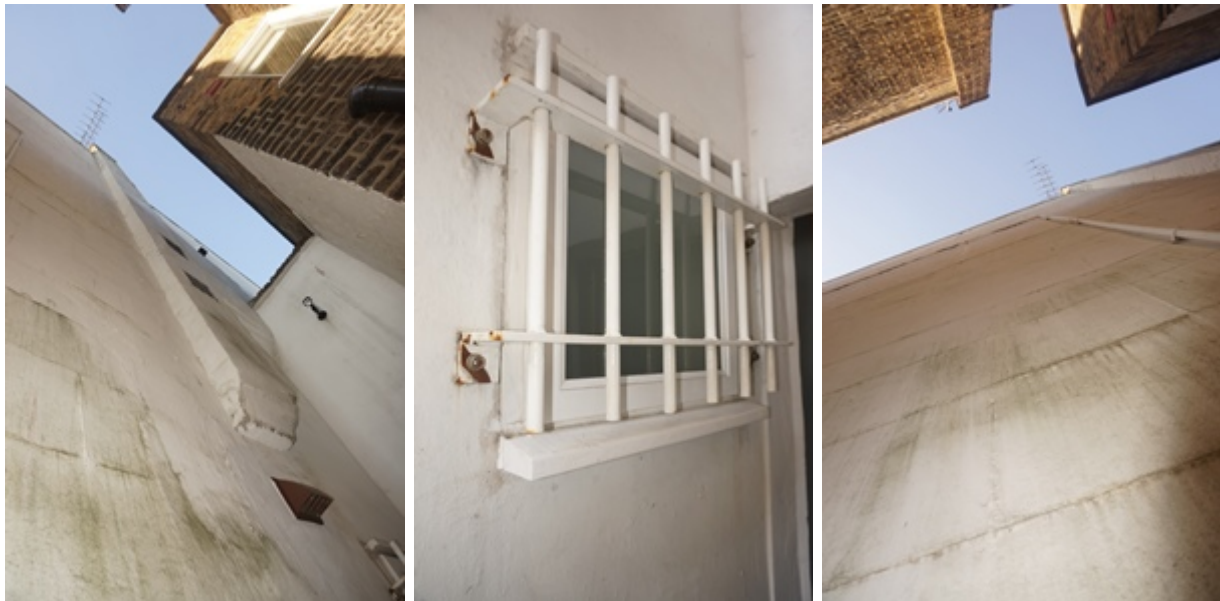
Turning to the gable elevation, the decoration is poor, again having been repainted and noting the rendering to the ground floor level and breather vent to the left and coarse repairs to the bottom render no doubt due to external rising damp and generally external render which is painted which does nothing but encourage rising damp inside and it was noted that there are some breather vents that have been fitted approximately 500mm from the ground level suggesting that there has been an ongoing frustration with rising damp.

To the left there does not appear to be a rodding eye to the main foul pipe and noting to the right of this the boiler flue is approximately 7m from the ground level and overflow pipe from the boiler beneath that in copper although a further supply pipe, possibly for the visitors' WC, which should be insulated, whether hot or cold.

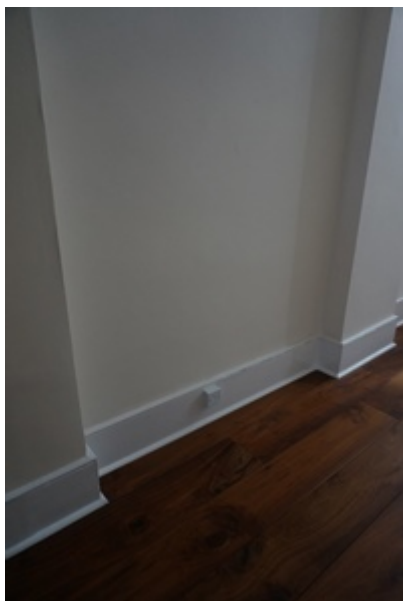
Random though not exhaustive damp testing was carried out to the ground floor and no readings were detected except at low level just above the skirting in the hallway to the outer wall, noting the comment above regarding previous introduction of breather vents (though no odour or visual disturbance was noted).
