BY HOGAN LTD

2.0 SUMMARY

Further to instruction on (date) Hogan Associates attended the above property on the afternoon of (date) to carry out a building survey.

This substantial, freshly modernised, end of terraced property faces in an easterly direction and provides accommodation by way of five bedrooms, over five floors, from basement¹ through to third floor complemented by a roof terrace and access to communal gardens to the rear of the property.

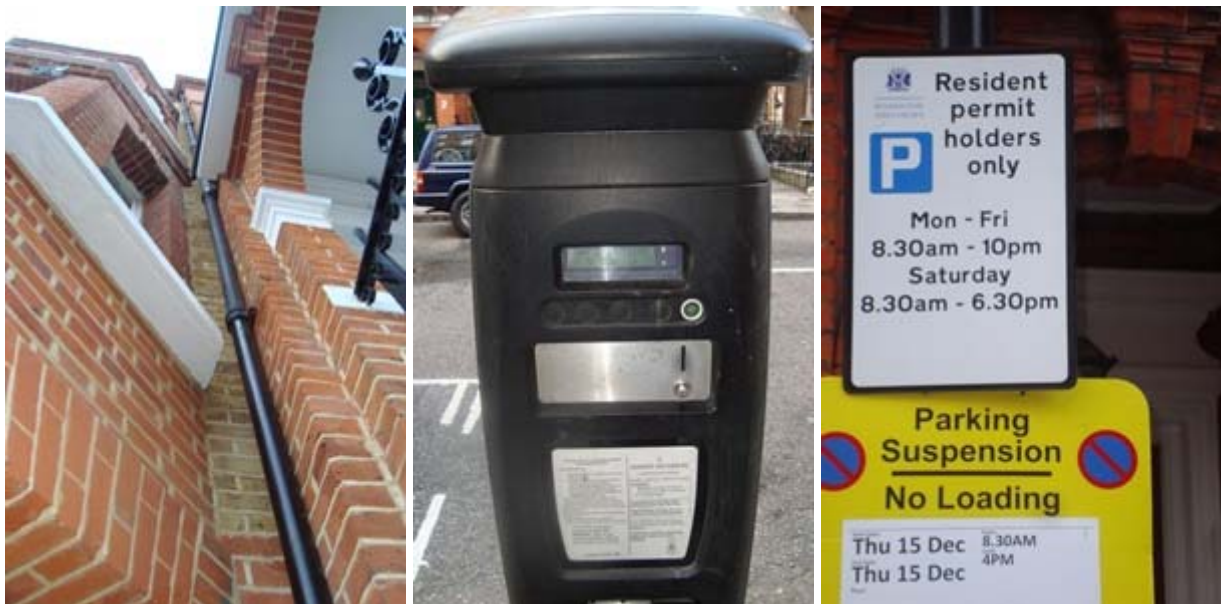
Turning to the front (facing east), side and rear elevations:

All of the construction components are in very good order including parapet stones, stonework around windows, brickwork, rainwater goods, flashing details, rainwater goods etc.

New windows have been fitted throughout.

There is an access gate within the railings, to the left of the property, providing a route through to the basement entrance. This would benefit from having a new lock fitted (and closing spring).

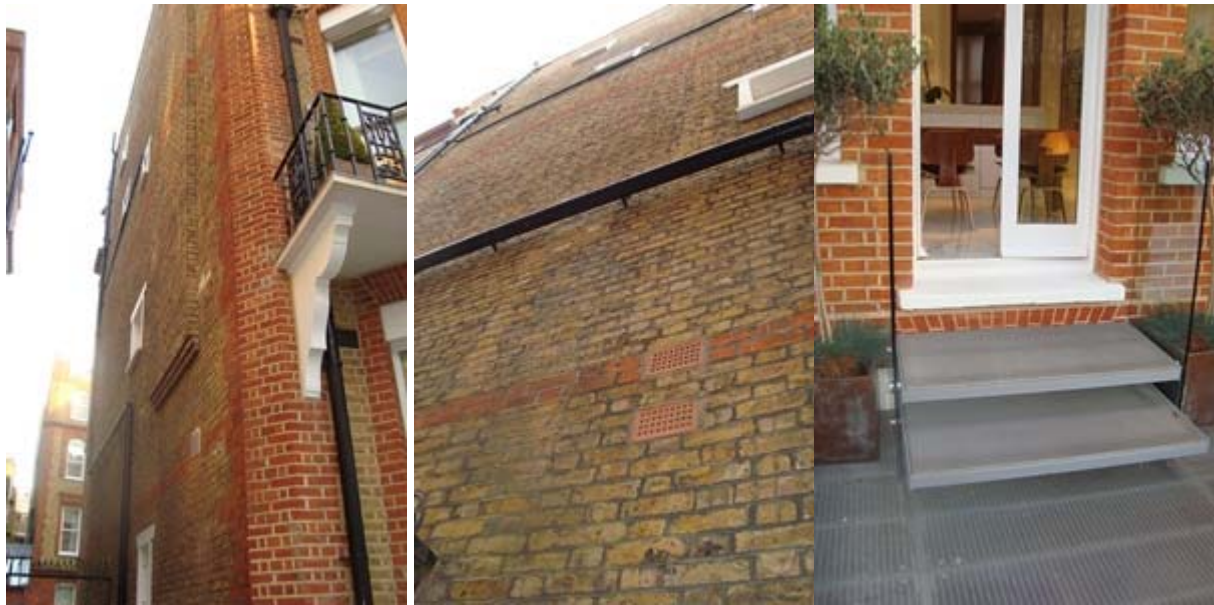
With regard to the stone balcony to the rear (at first floor level) this appears structurally sound – there are no indications of any distress and it is supported by 6 buttresses.

The metal decking area to the rear allows light to diffuse to the basement.

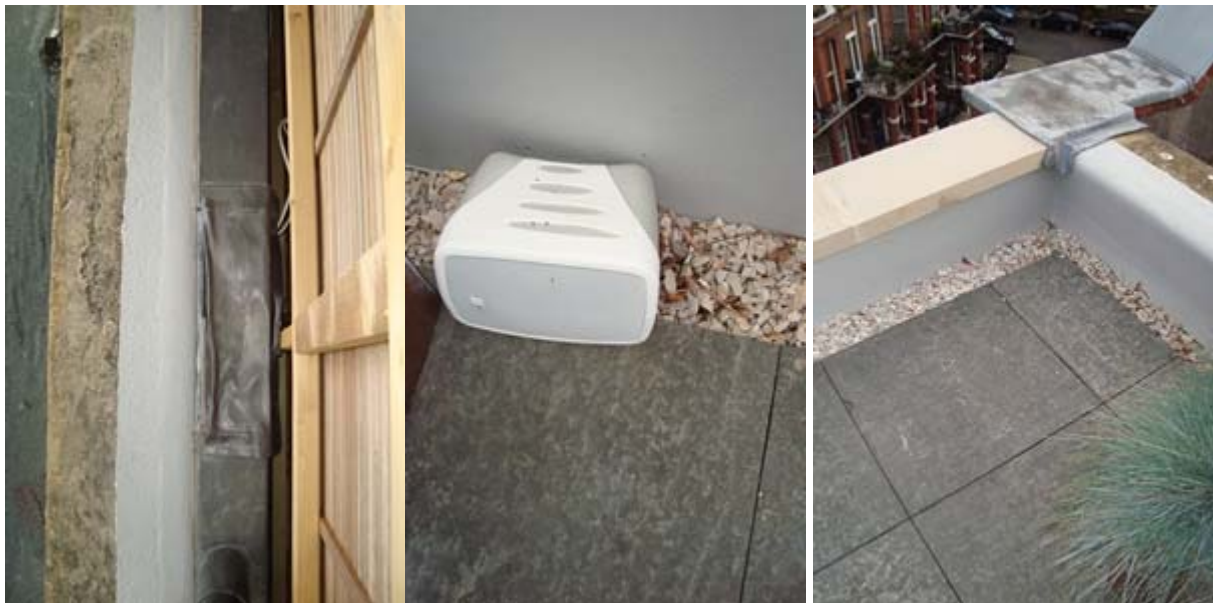
There is a timber slatted fence mounted against the party wall (which has feature lighting to the right) – it also has a power socket and water supply. Some minor “making good” to the lead work is required:

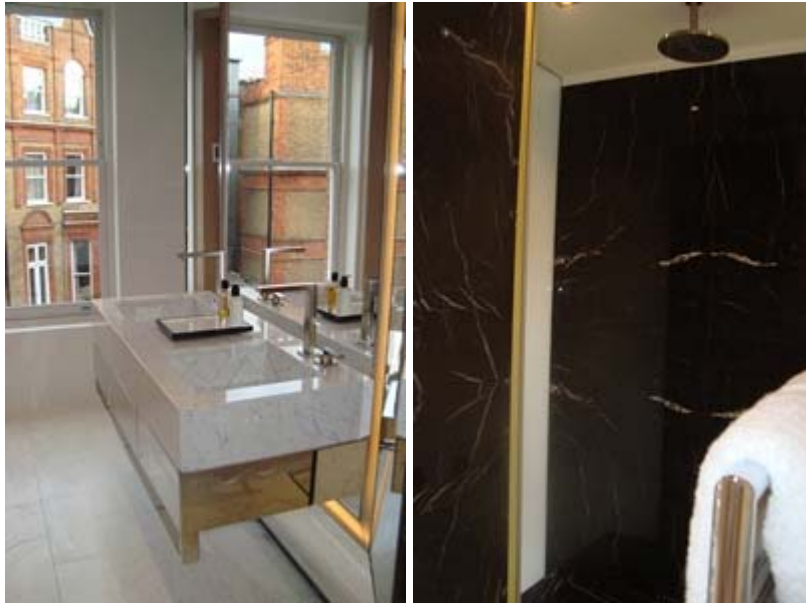
To the right there is a sit in shower – two showerheads mounted at ceiling level complemented by a hand held showerhead. All three tested satisfactorily as did the monobloc mixer taps to the double sink, W.C. and bidet.

The water appeared slightly contaminated and should be checked⁴. It may also be (safety) constrained on temperature.

⁴ The system should be thoroughly flushed through

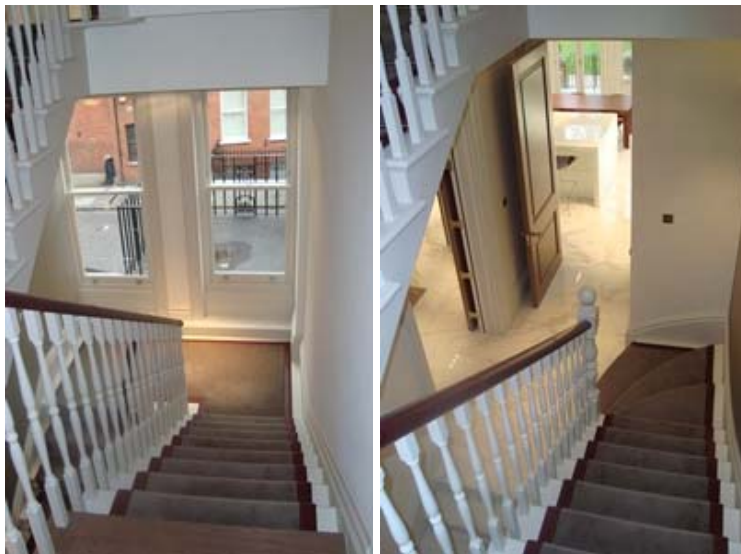
Photograph of stairs down to ground floor noting that at half-landing level there is a small terrace above the entrance to the property, although this could not be accessed due to the restriction on (both of) the sash window(s).

Photograph, above, of stairs down to ground floor with kitchen area in the background and the communal gardens in the distant background.
