HOGAN LIMITED

1.0 SUMMARY

Further to instruction on 10th September 2020 Peter Hogan FRICS of Hogan Ltd attended the above property on the afternoon of Monday, 14th September 2020 to carry out a building survey.

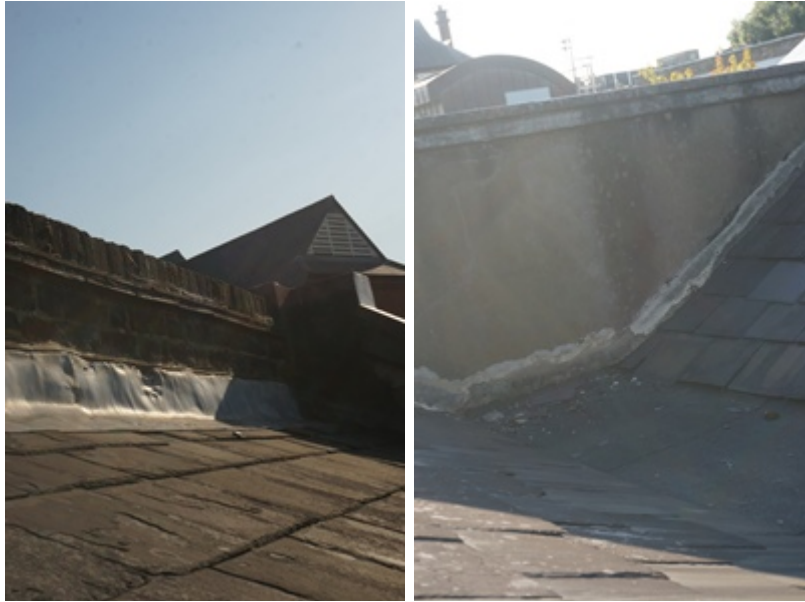
It was possible to inspect the roof and the chimney stack which is in good order, as are the parapet walls on the whole though these should be inspected every two years as inevitably mortar and indeed bricks can be susceptible to frost damage (known as 'spalling') due to their remoteness and relatively high surface area compared with their volume.

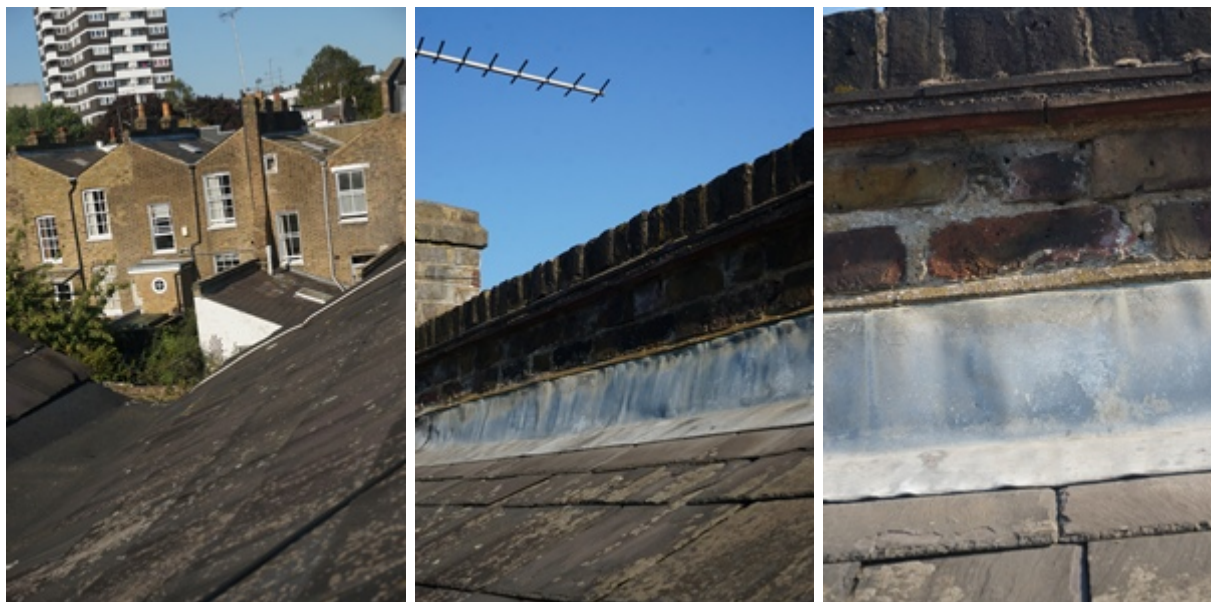
However, the roof slates are clearly suffering from systemic nail fatigue, i.e. with the nails assumed to be ferrous and there are a great number of slates which have been re-fixed using 'lead tabs'.

These will continue to slip and require replacement though the roof can be maintained for many years to come, but clearly a decision was made to do this given the relatively new refurbishment to other areas, and the rear roof has been covered with a synthetic tile noting the breather vents set up towards the ridge line which has on the top of it a metal capping with lead detailing beneath dressing onto the synthetic slates; this structure being the gable wall.

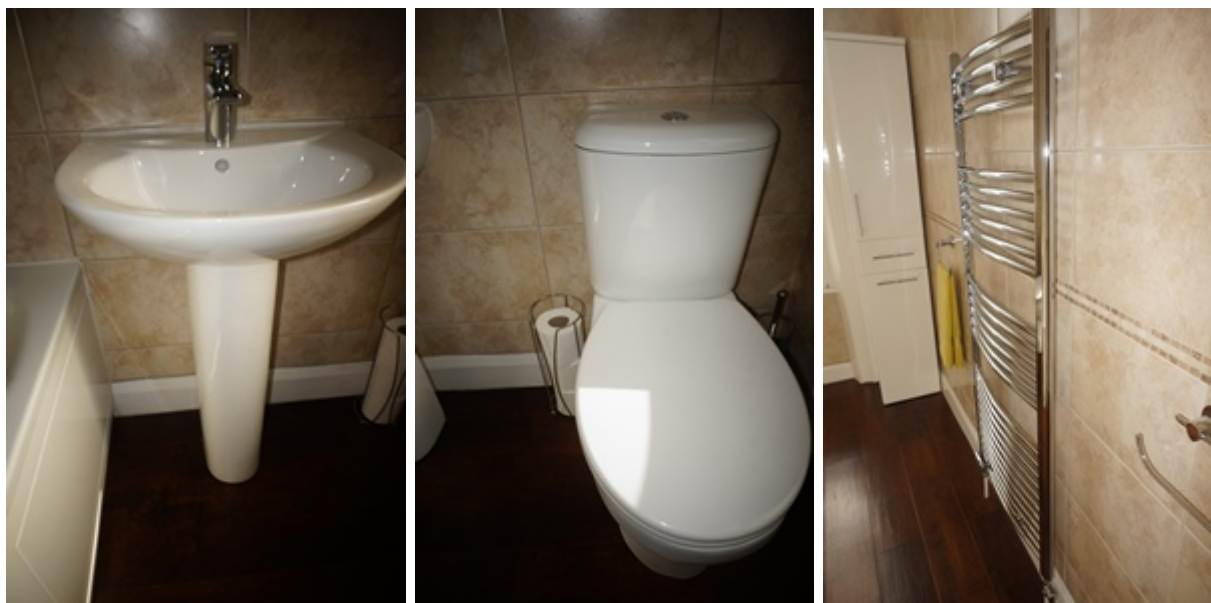
To the foot of the bath there is a pedestal wash hand basin with mixer tap and beyond that a floor mounted close coupled WC and adjacent to that is a obscured sash window and **noting the relatively low sill height** although there is an option to have restricted opening using dead bolts.

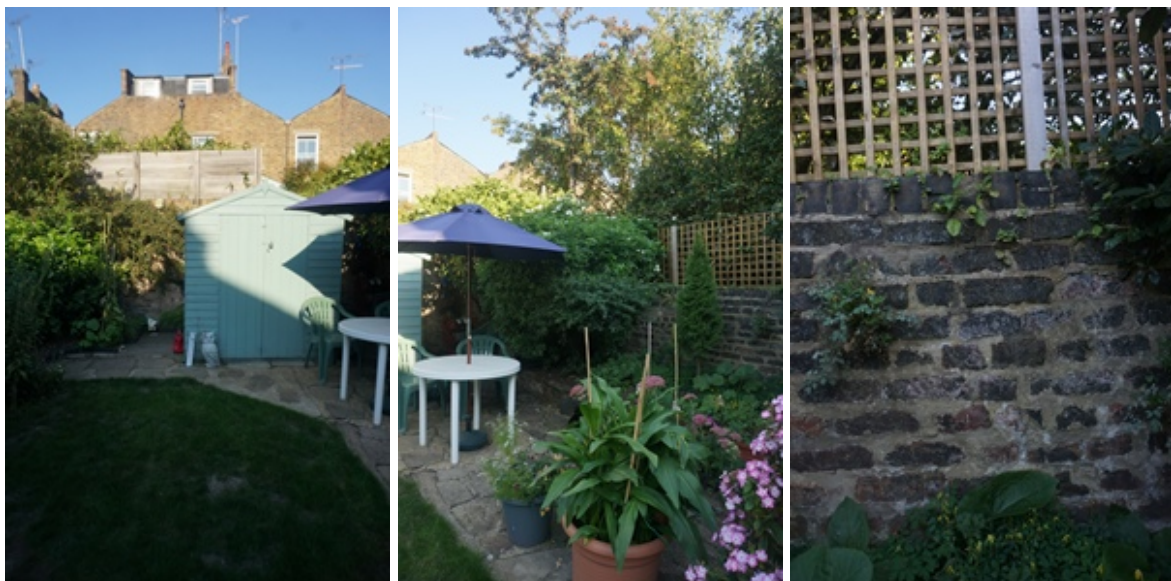
To the left there is a very aged assumed solid 9" wall on top of which there is an elegant timber fence and the fence would benefit from preservative and the wall is generally in reasonable condition though there is some coarse repointing and further repointing would be appropriate and noting some spalling (frost shattering) to the face brickwork, e.g. approximately 5m from the rear wall which is also of solid construction and again has a timber fence on it but in this case on the neighbour's side.

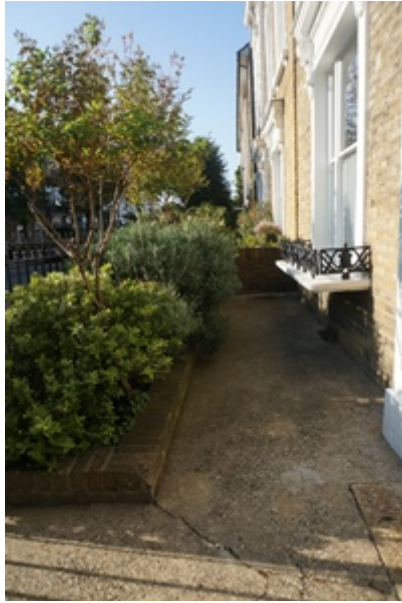
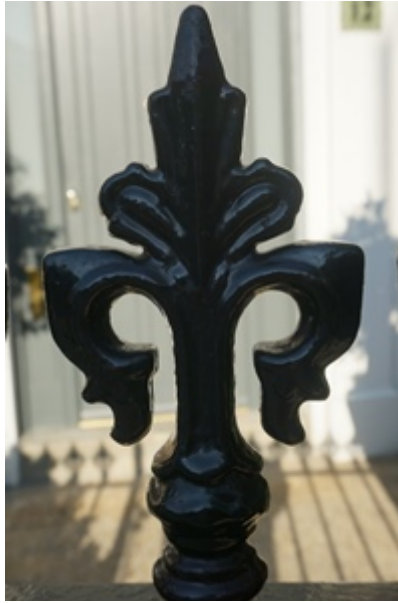
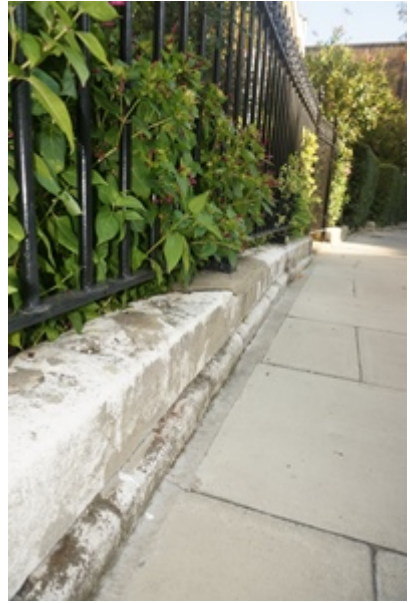
With regard to boundaries, there is a single skin brick wall shared with the neighbour to the left which is structurally sound but quite coarse and would benefit from cleaning and noting on the neighbour's side there is a section that is chased out but for unknown reasons, possibly services, i.e. CCTV etc.

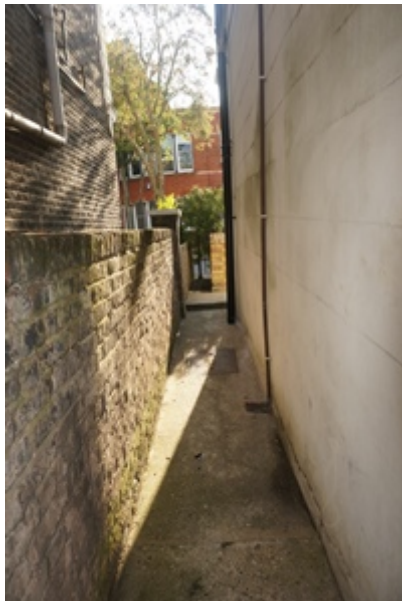
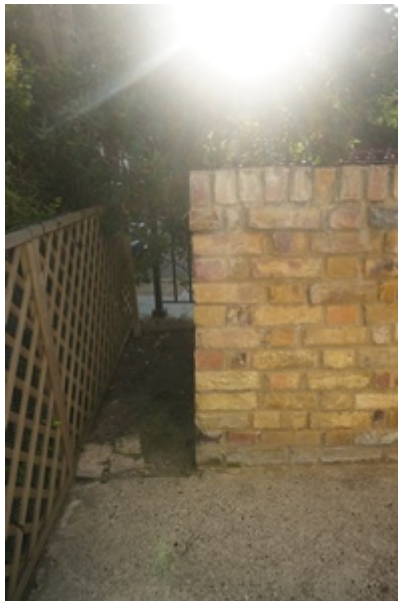
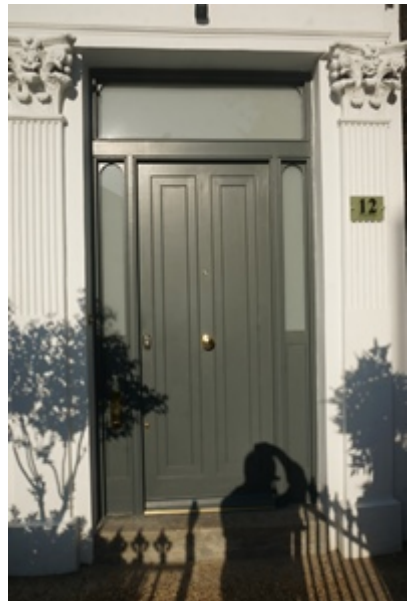
With the public pavement there is a low level bund wall which is quite visually strong but has had and requires repairs and set into which is a black painted railing, to the right of which there is a gate.
